Conveyor Preventative Maintenance

Team Members: *Tristan Ehman, Ryan Elmore, Joshua Kim, Patrick Berger*
Mentor: *Ralph Munguia*

The objective of our project is to create a computer vision machine learning system that notifies the client when weld cracks and failures occur. The system should be compatible with the current track system at John Deere for seamless implementation and have self-sufficient power that lasts for the entire conveyor ride.

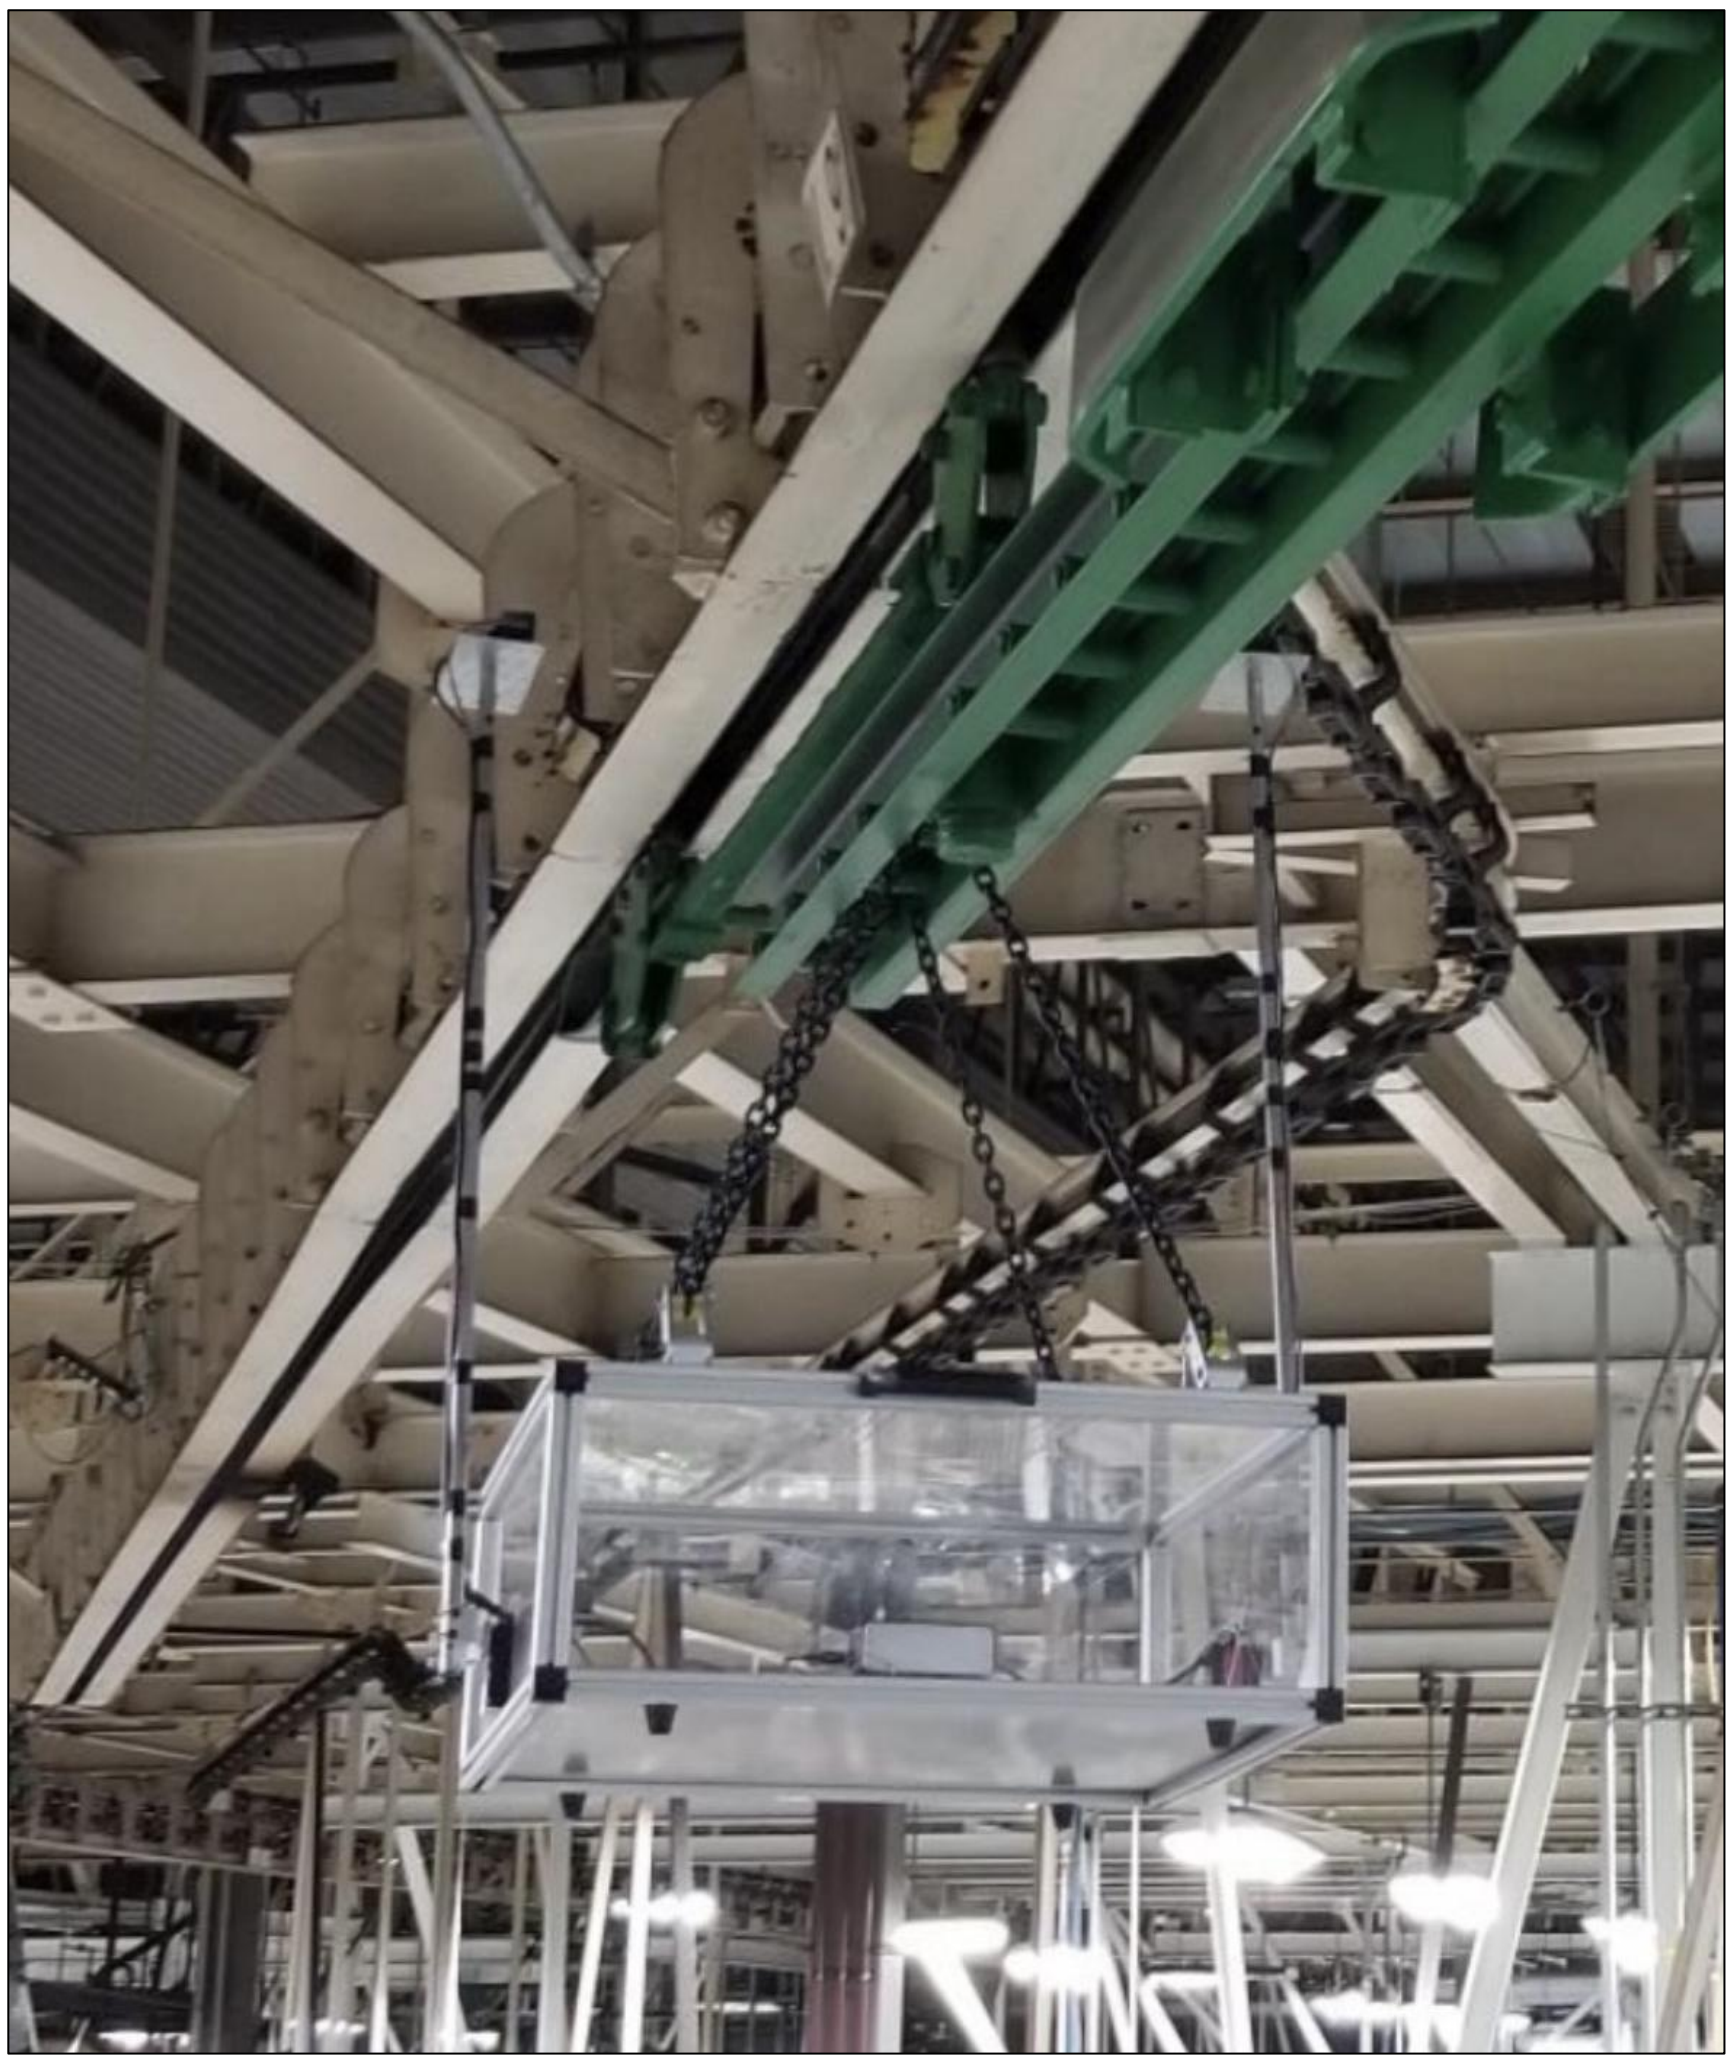
The requirements for our system included being self-sustaining for several hours while roaming the track, the ability to automatically move the arms to avoid collisions, and the integration of machine learning-based weld detection software. Our team was able to meet all of these requirements with the final design shown to the right. The final design features an 80/20 frame with a sheet metal bottom and non-metal, laser-cut sides and top, creating a fully enclosed system resistant to dust. Attached to the frame, our team installed one arm on each side, each housing a camera, two lights, and a LIDAR sensor. Servos were integrated into the design to enable the arms to move out of the way automatically, using data from the LIDAR sensors to detect and avoid obstacles.

Our final product consists of two cameras, two LIDAR sensors, four LEDs, two Arduinos, one Raspberry Pi 5, and two battery packs. It is capable of detecting cracks using the cameras and saving the images to the Pi's local storage. The pictures gathered during testing revealed that our system was able to detect cracks accurately. However, due to the nature of the factory environment, many objects were mistakenly detected as cracks. The arm system of our project worked somewhat as expected. However, due to the servo motors coming loose, the arm was tilted and was unable to move properly to avoid certain obstructions.

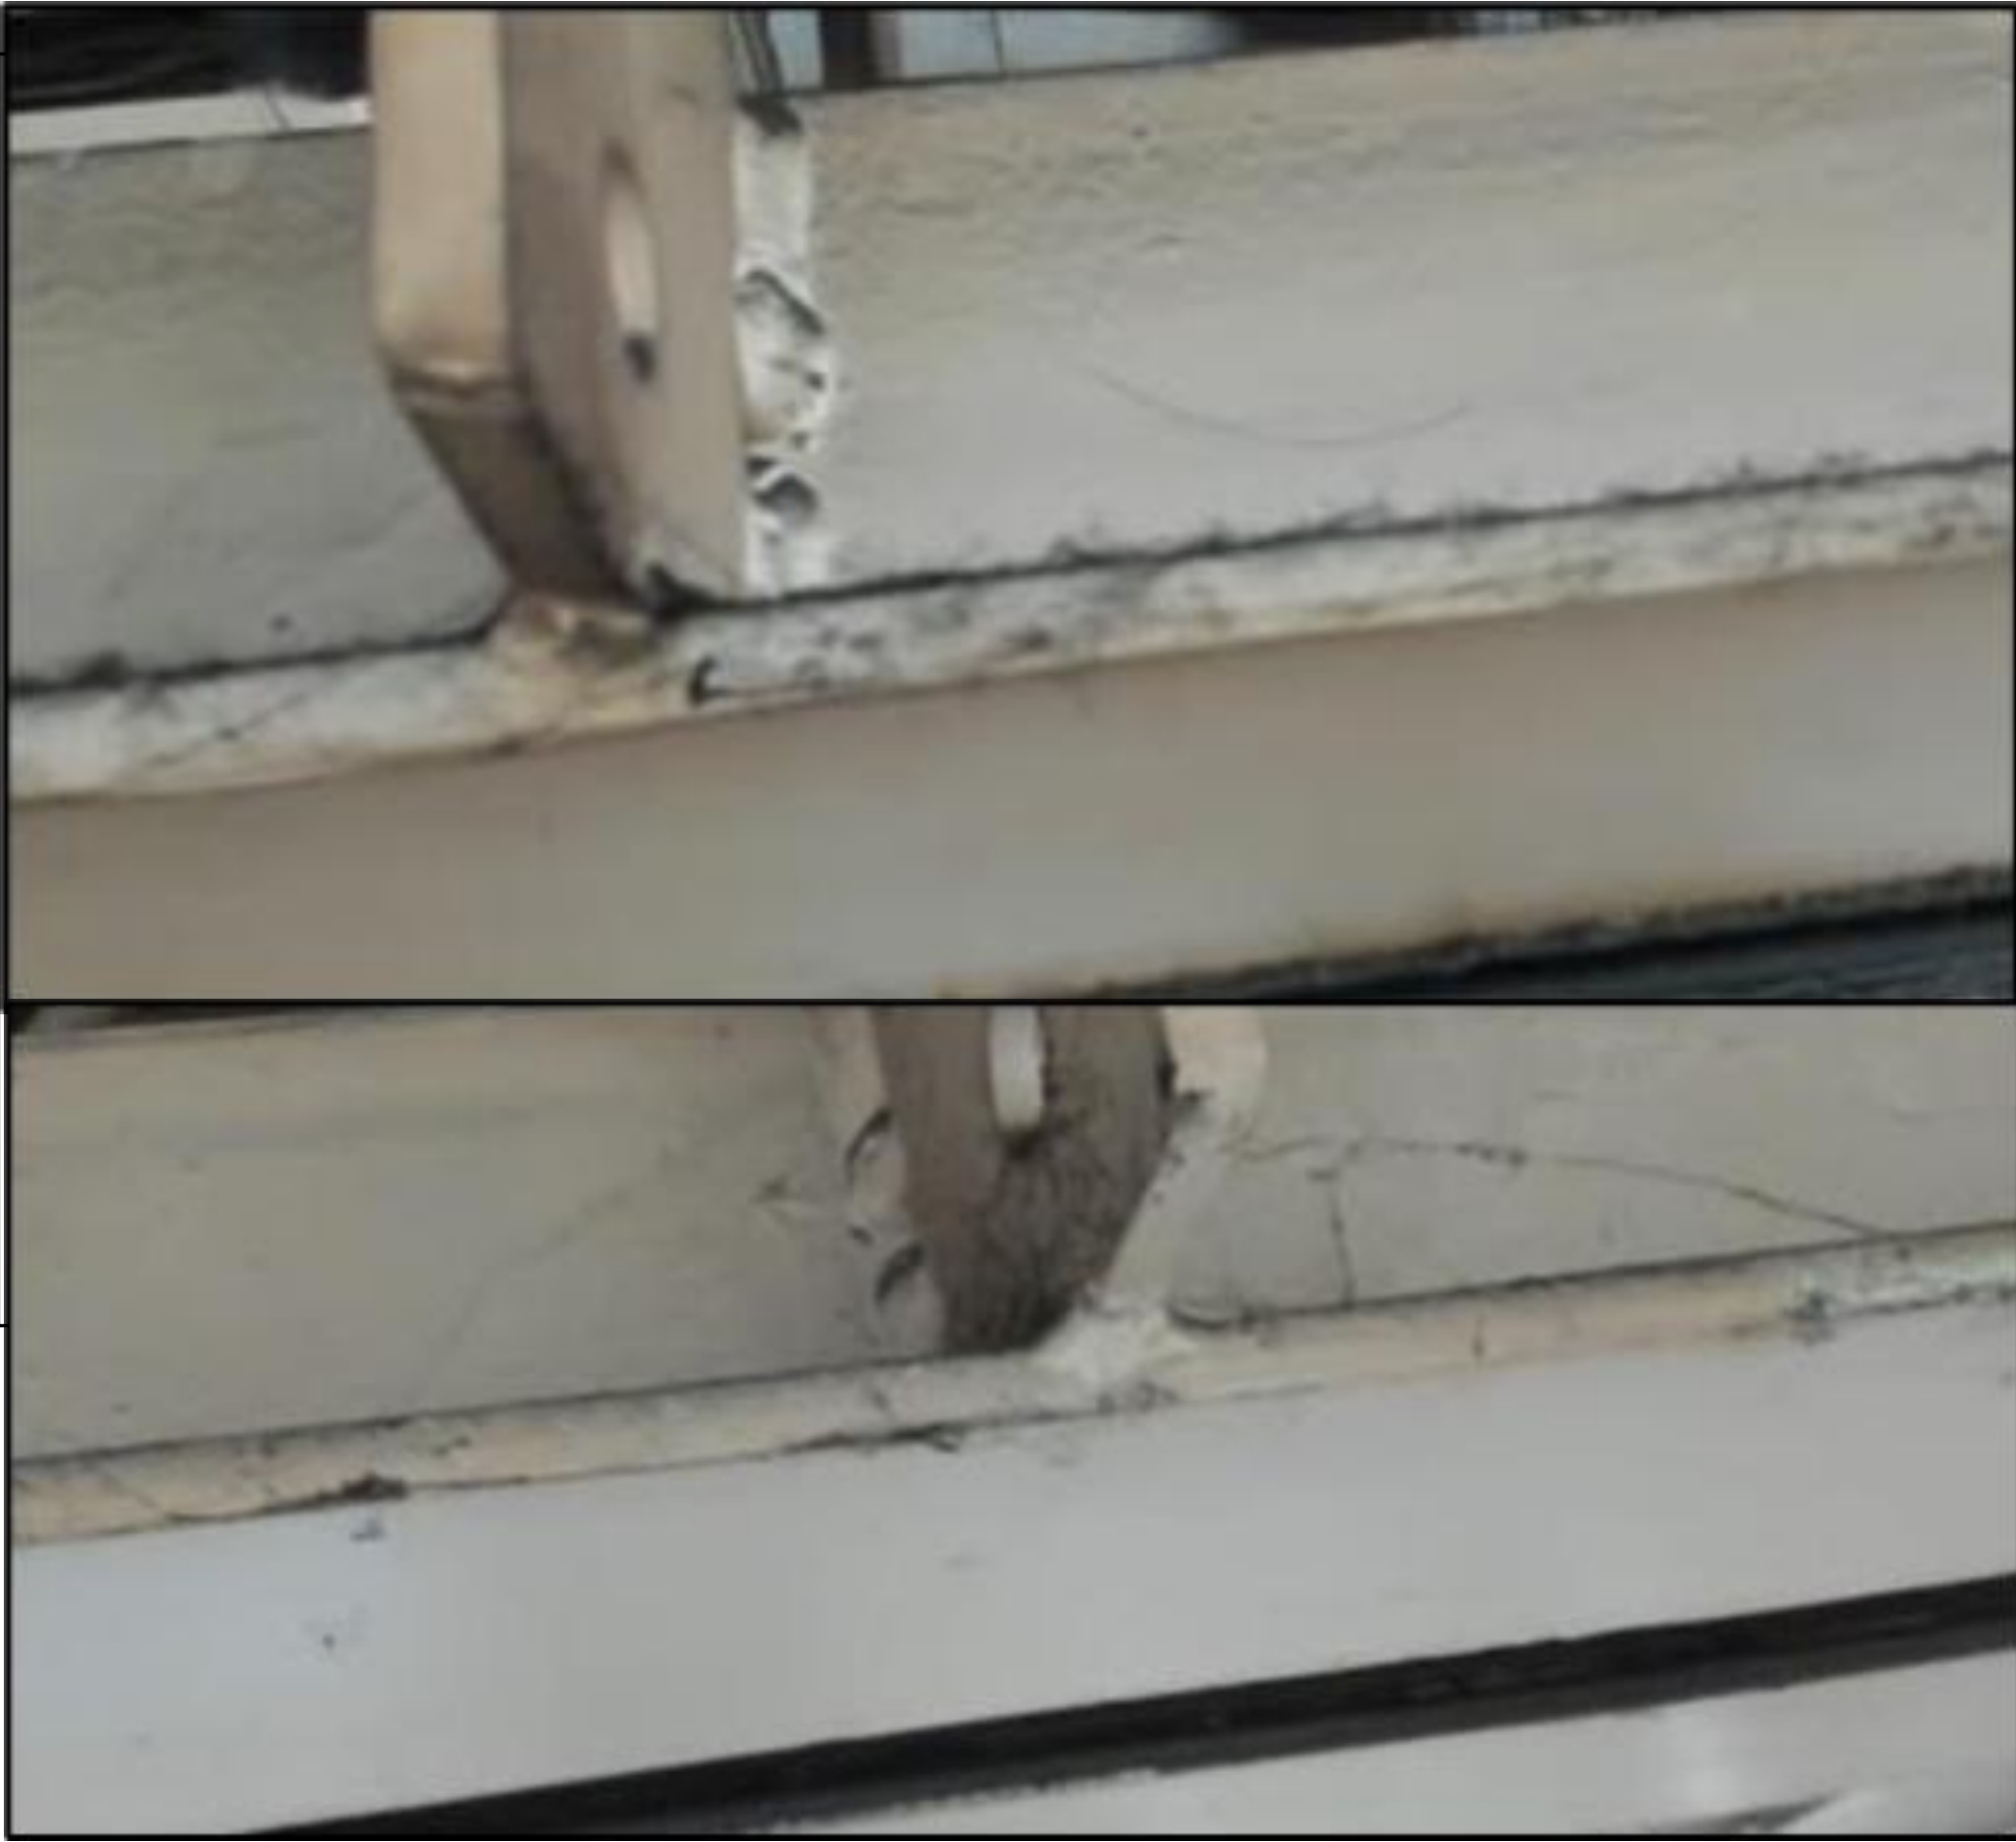
When tested, our product worked a little differently as expected. Our cameras were not able to take the most optimal photos due to the servos being loose, causing the arms to be in lower angles. The camera was also too sensitive when detecting cracks. The LIDAR sensors worked well when objects were detected. The battery life was better than expected, but there were some power draw issues related to the Arduino.
