High Temperature Cast Iron Materials for Exhaust Components

Team 20: Caterpillar MET / MSE Partnership

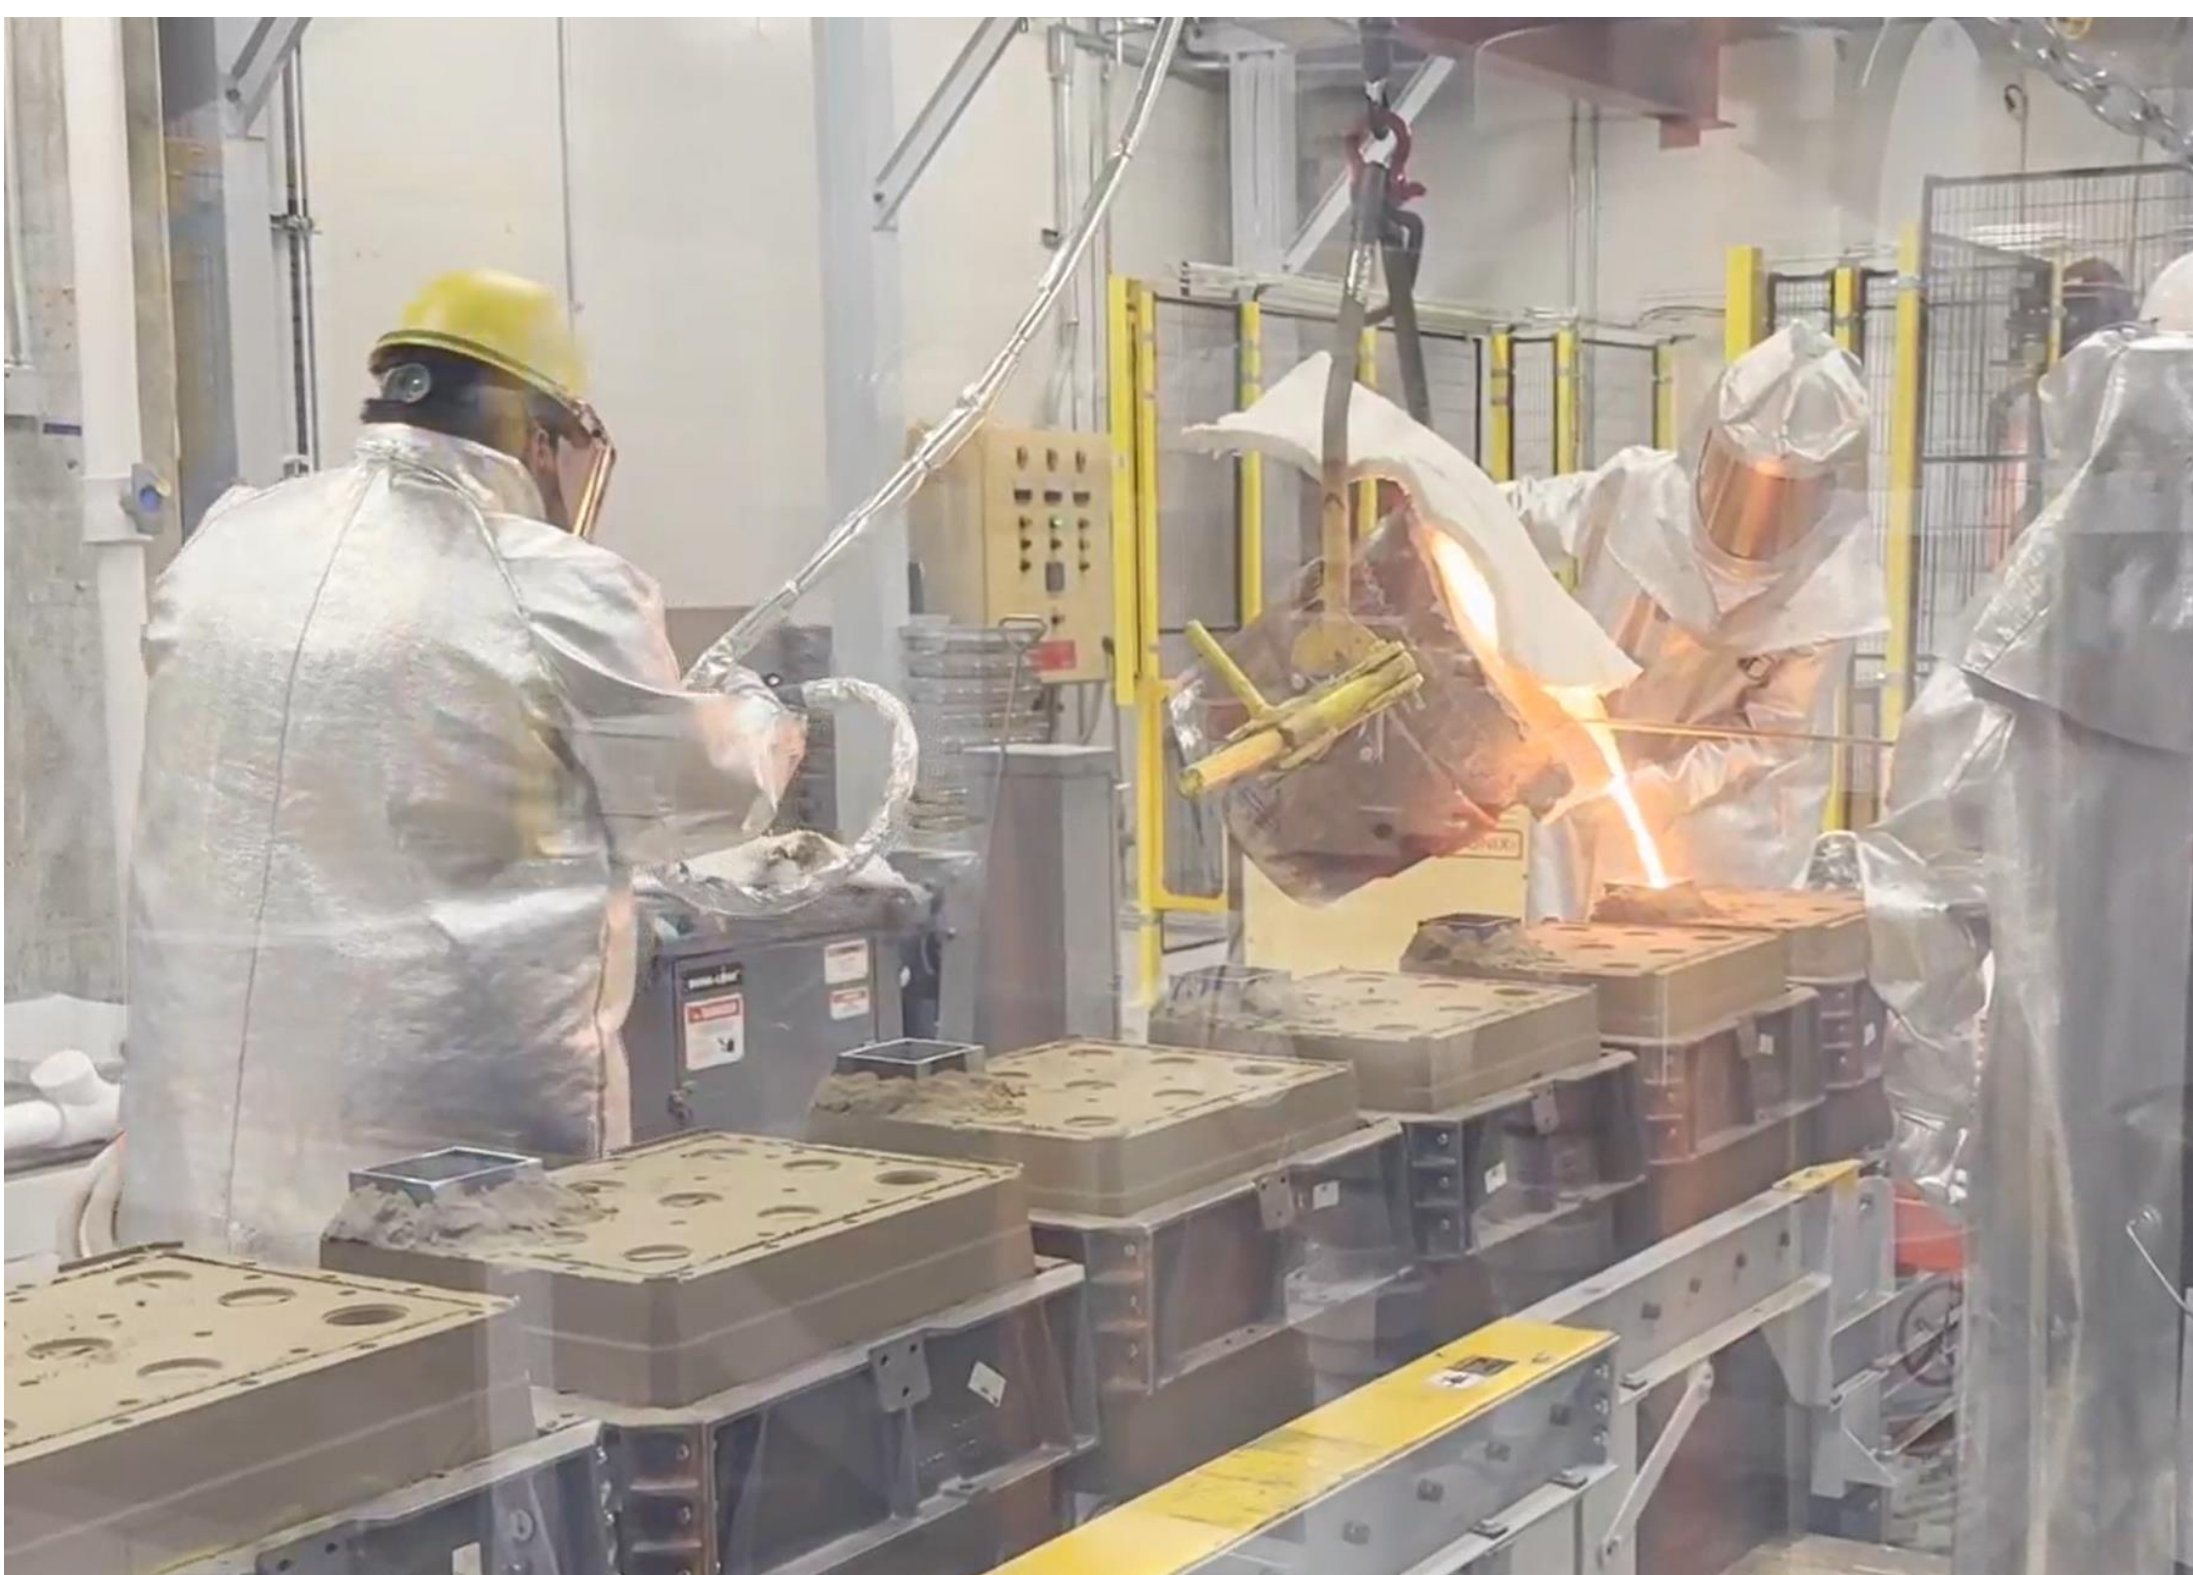
It is important for the runner/gating to be specially designed for quality castings. The runner has steps, with each step reducing the runner's cross-sectional area by the area of the gate. This allows for the flow rate and velocity to remain constant as the bars fill. The areas are also designed so that the fluid velocity is slow enough to prevent turbulence.

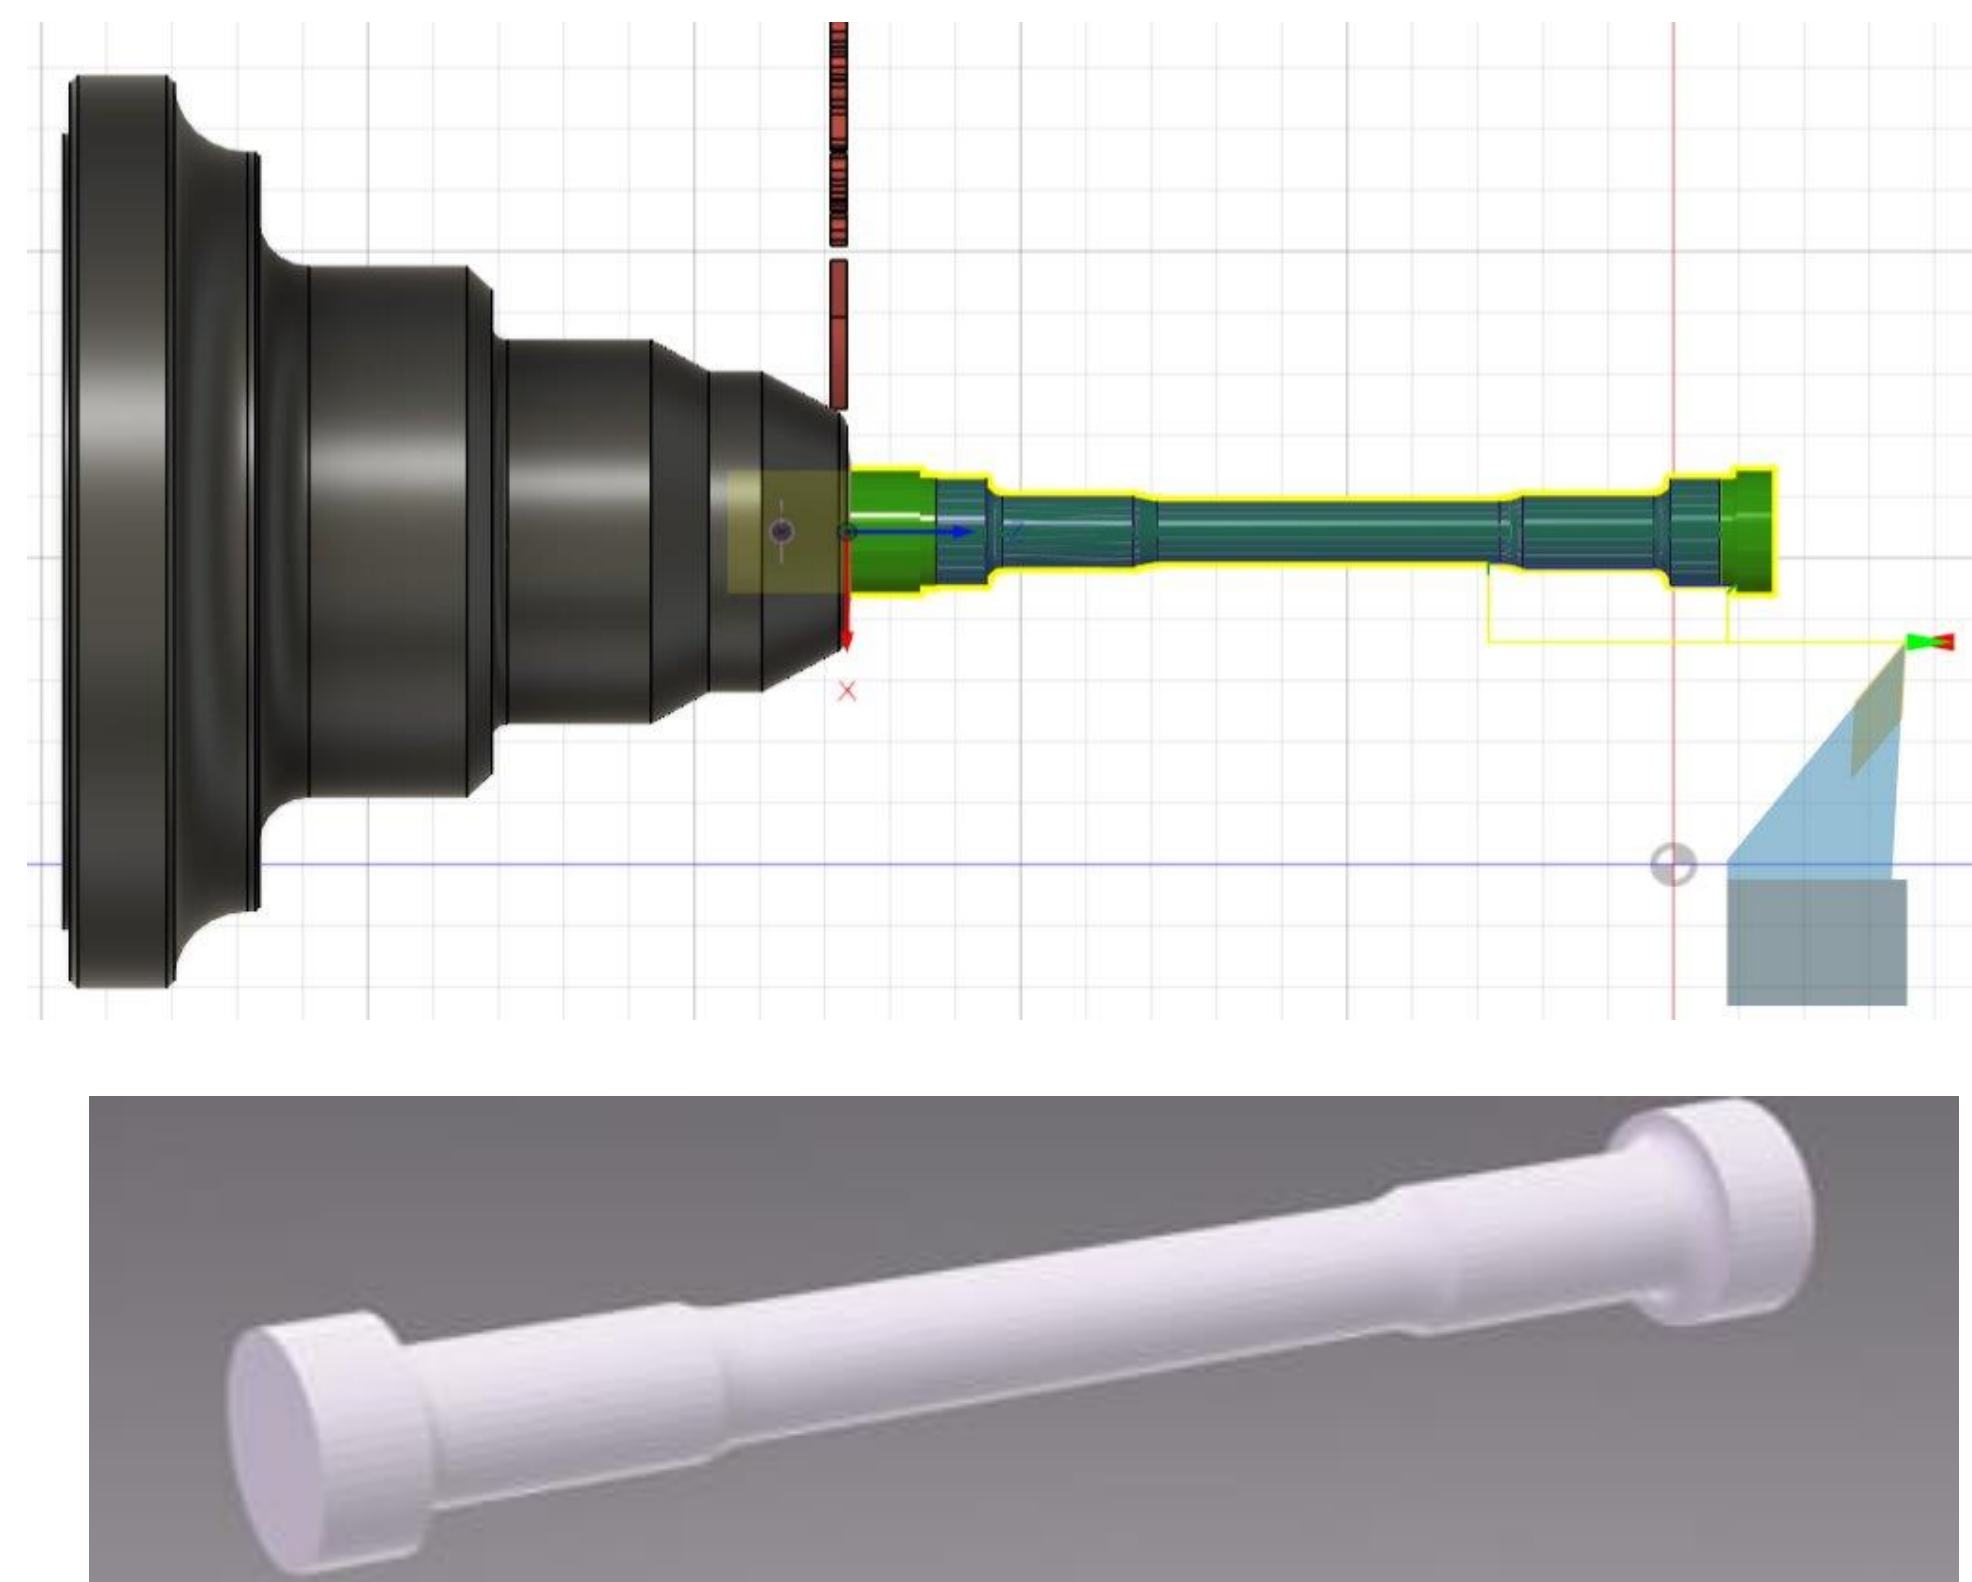
We created a CAD model of a CAT specified UTM bar spec. Due to the need of precise repeatability, we decided to use a CNC lathe. We created a program that would be used on an ST-20. Due to the lack of remaining time in the year, we were unable to machine the bar.

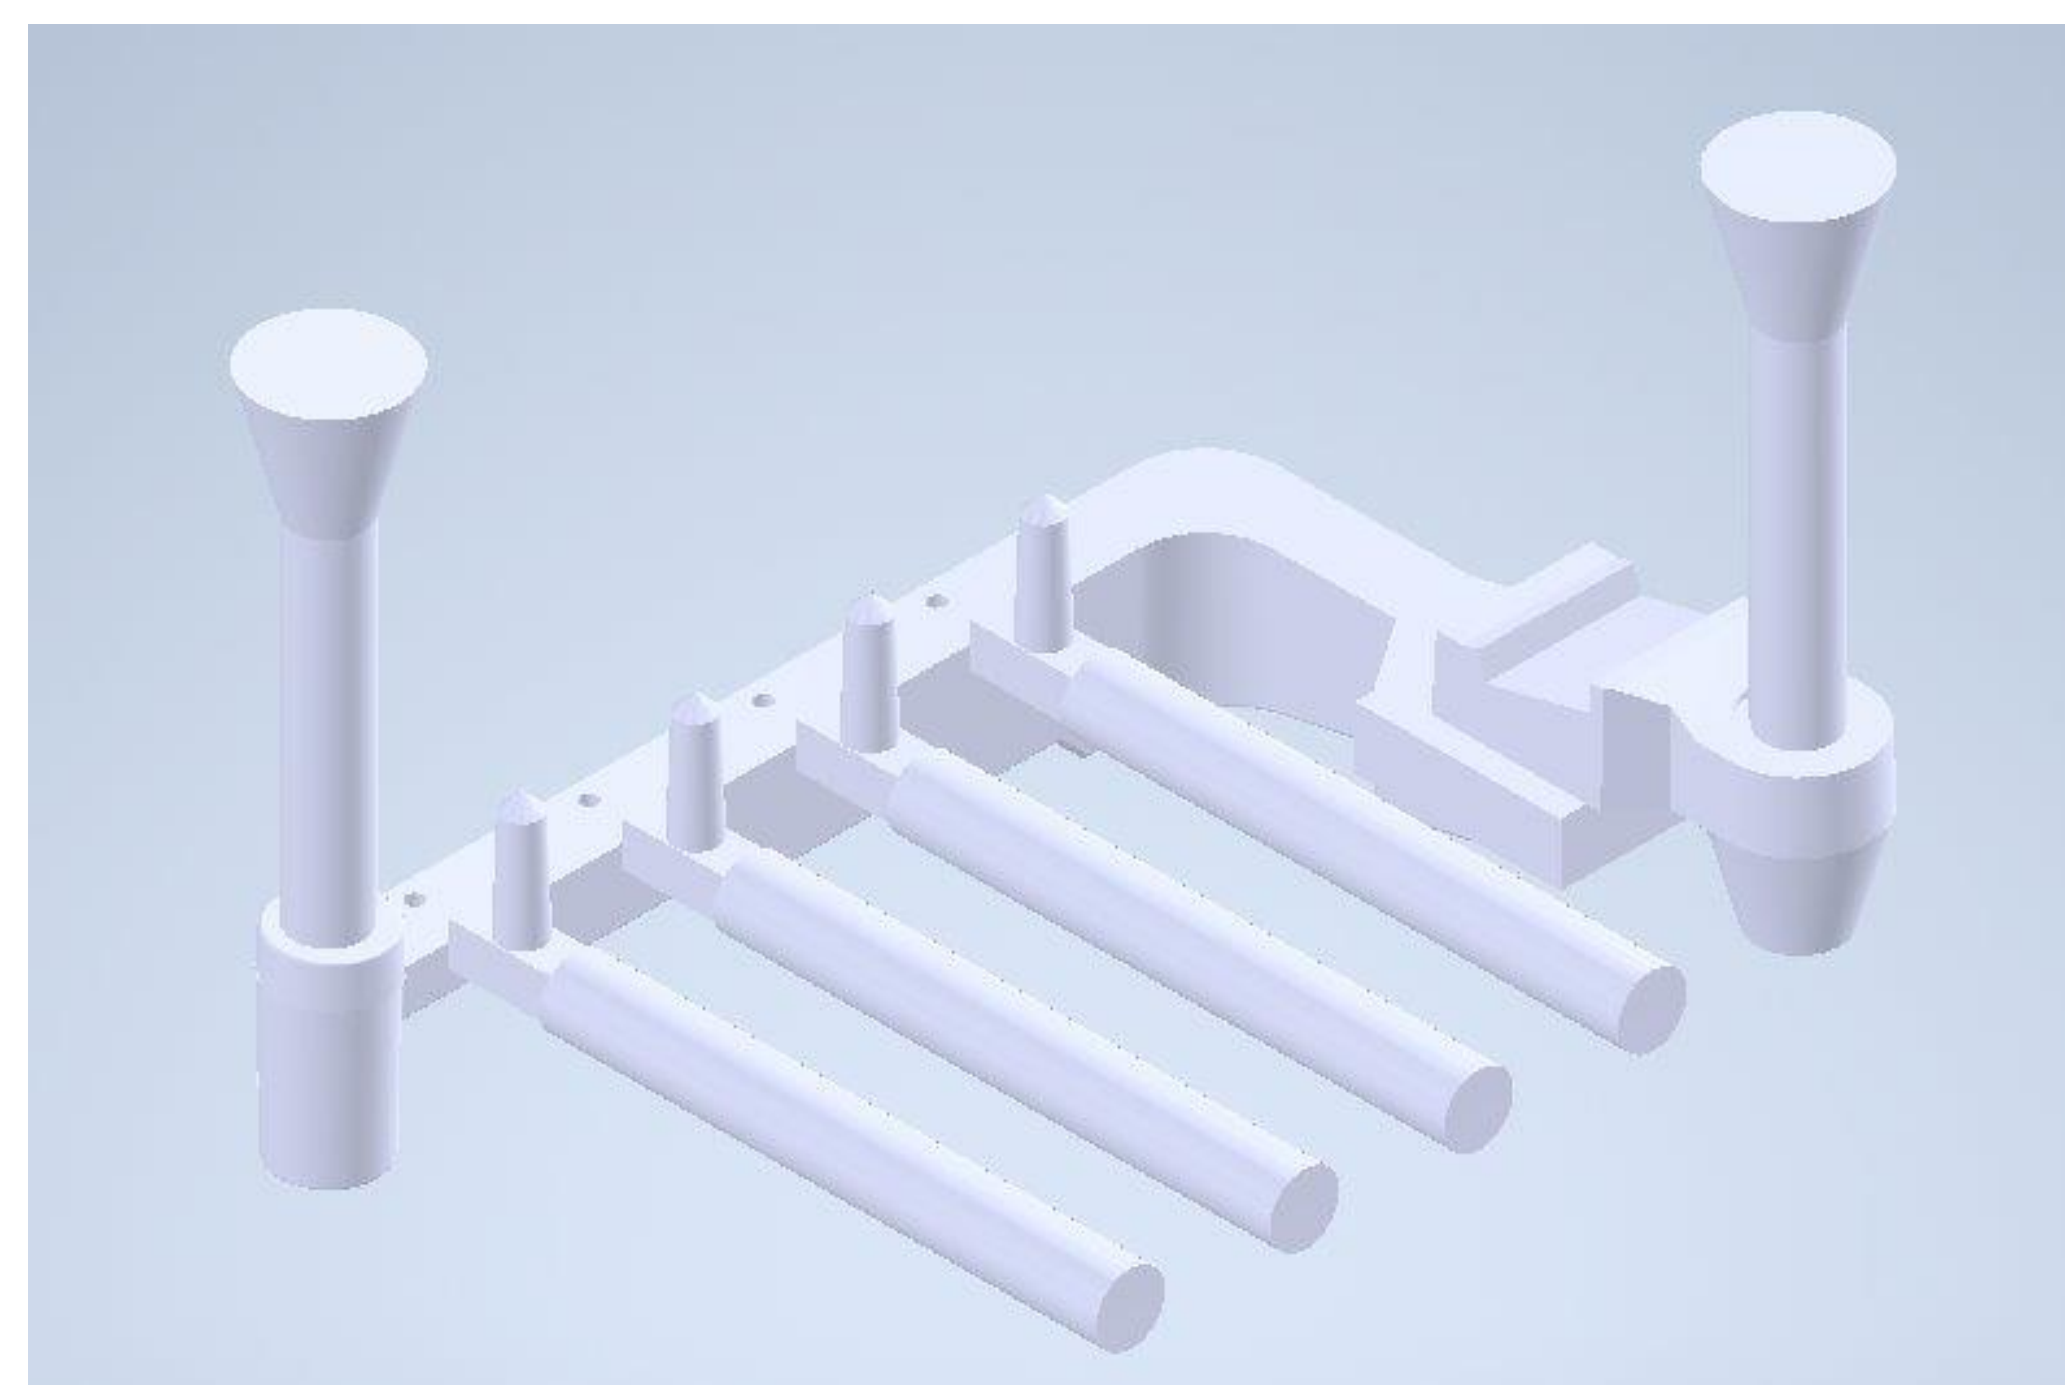
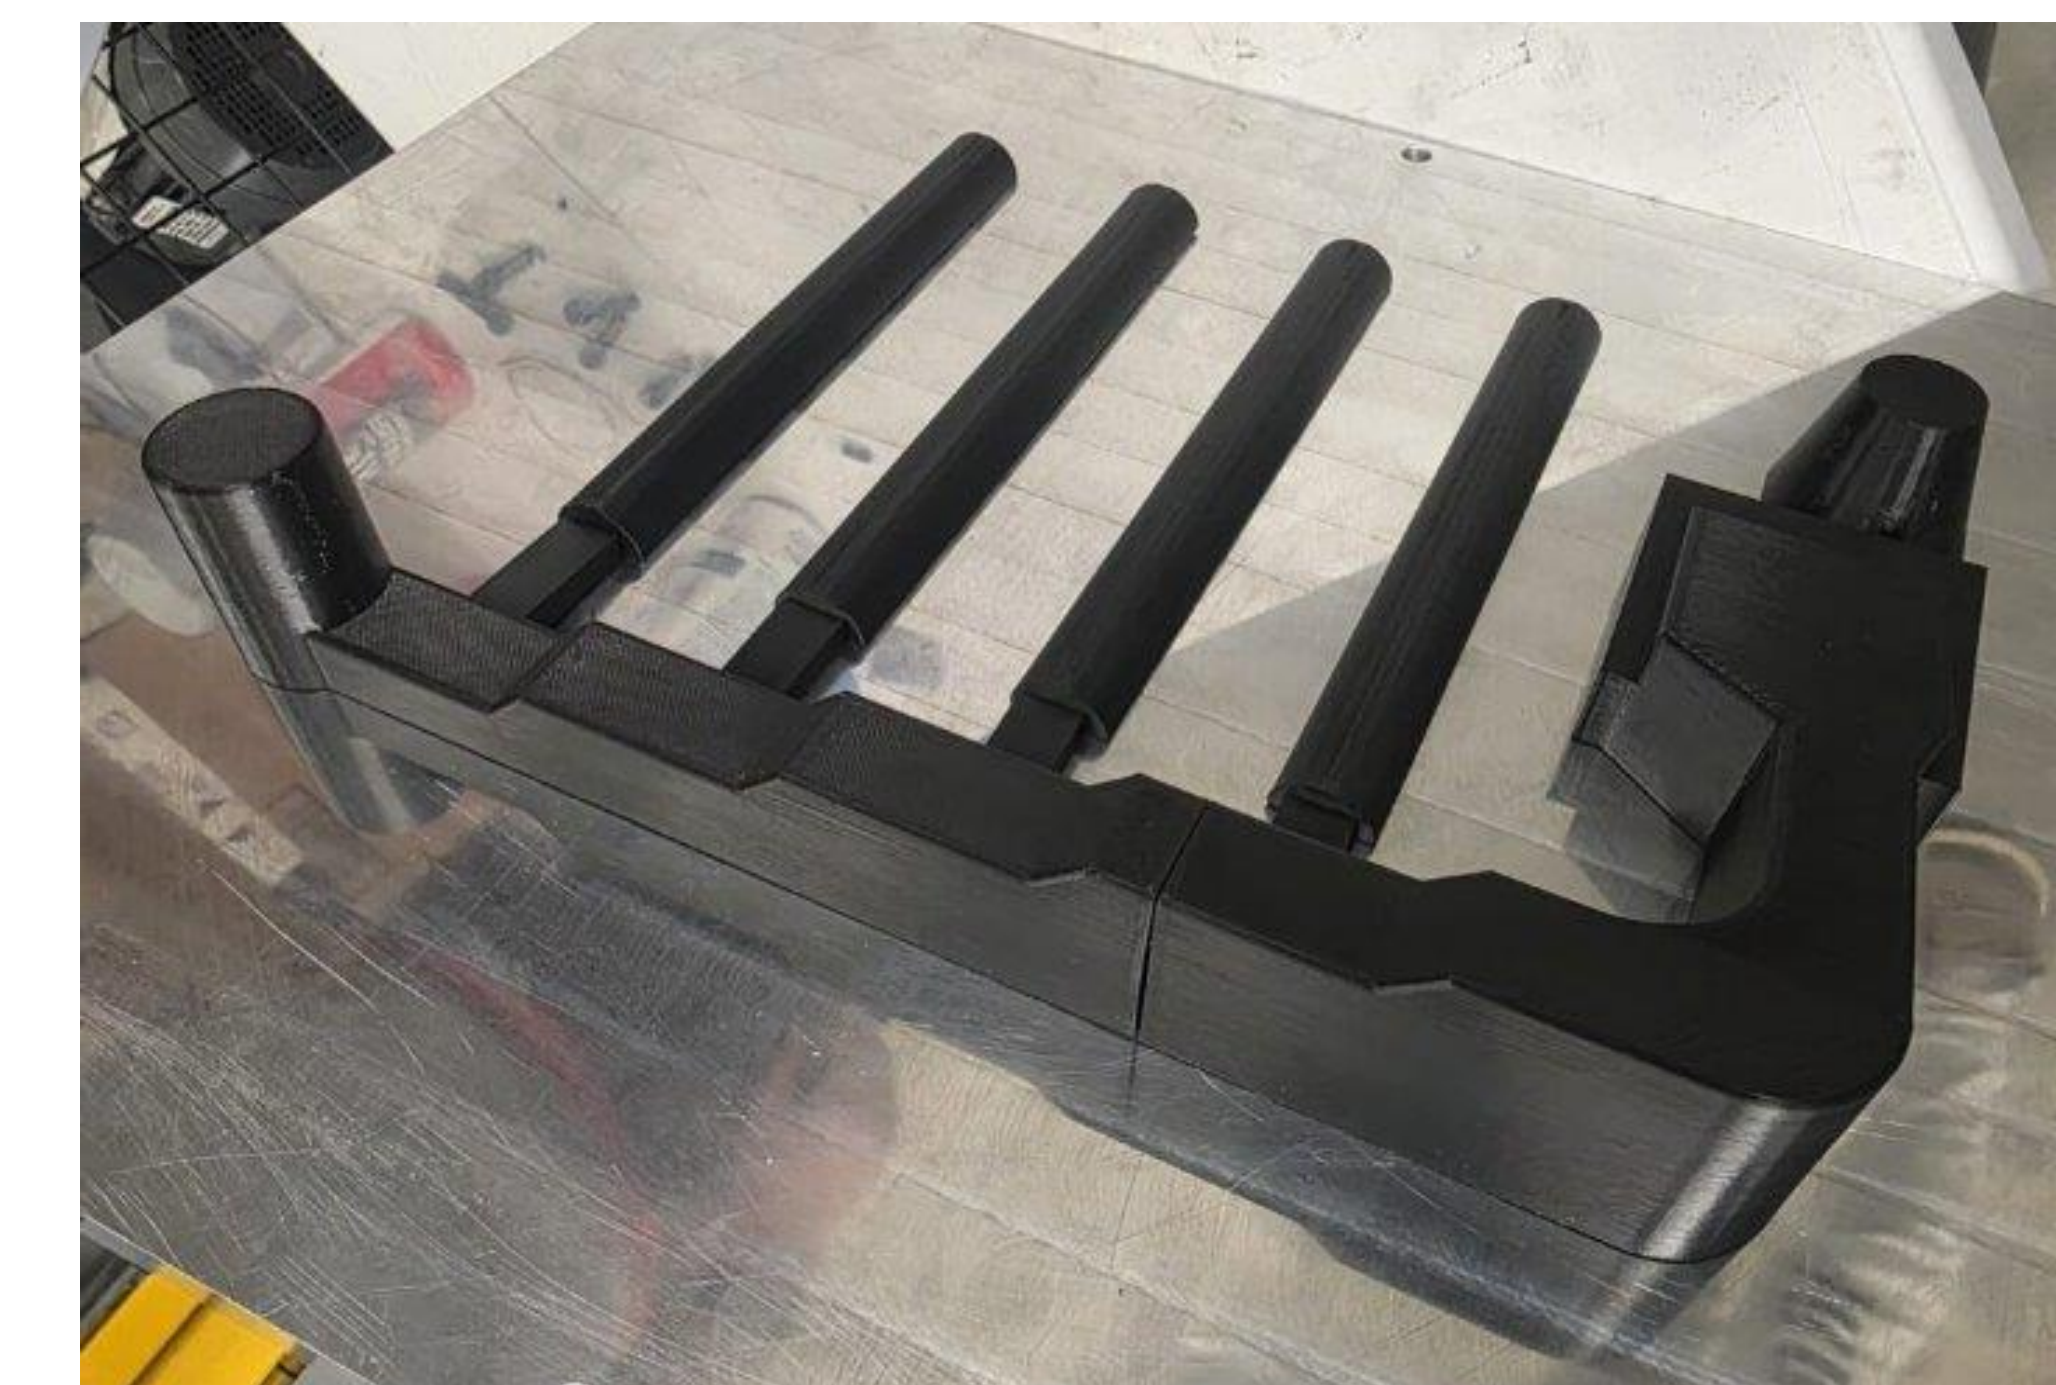
3D printed ABS pattern components were epoxied onto a machined 6601-T6 aluminum matchplate to make the pattern board. This was installed into the Sinto FDNX to produce the olivine sand mold. Before pouring the DI, jackets were added to help prevent floatation and breakout. A pouring cup was added as well to provide a larger pouring target; then molten iron was poured into the mold to produce the casting.

The final casting design has several parts to produce optimal castings. These include a well at the bottom of the sprue to contain the initial splash-down of the molten metal, a filter plus trap to prevent any slag/dross/non-metallics from entering the casting, a stepped runner to keep the flow rate consistent, another well at the end of the runner so the initial flow of metal does not splash back, and risers to attempt to prevent shrinkage defects.

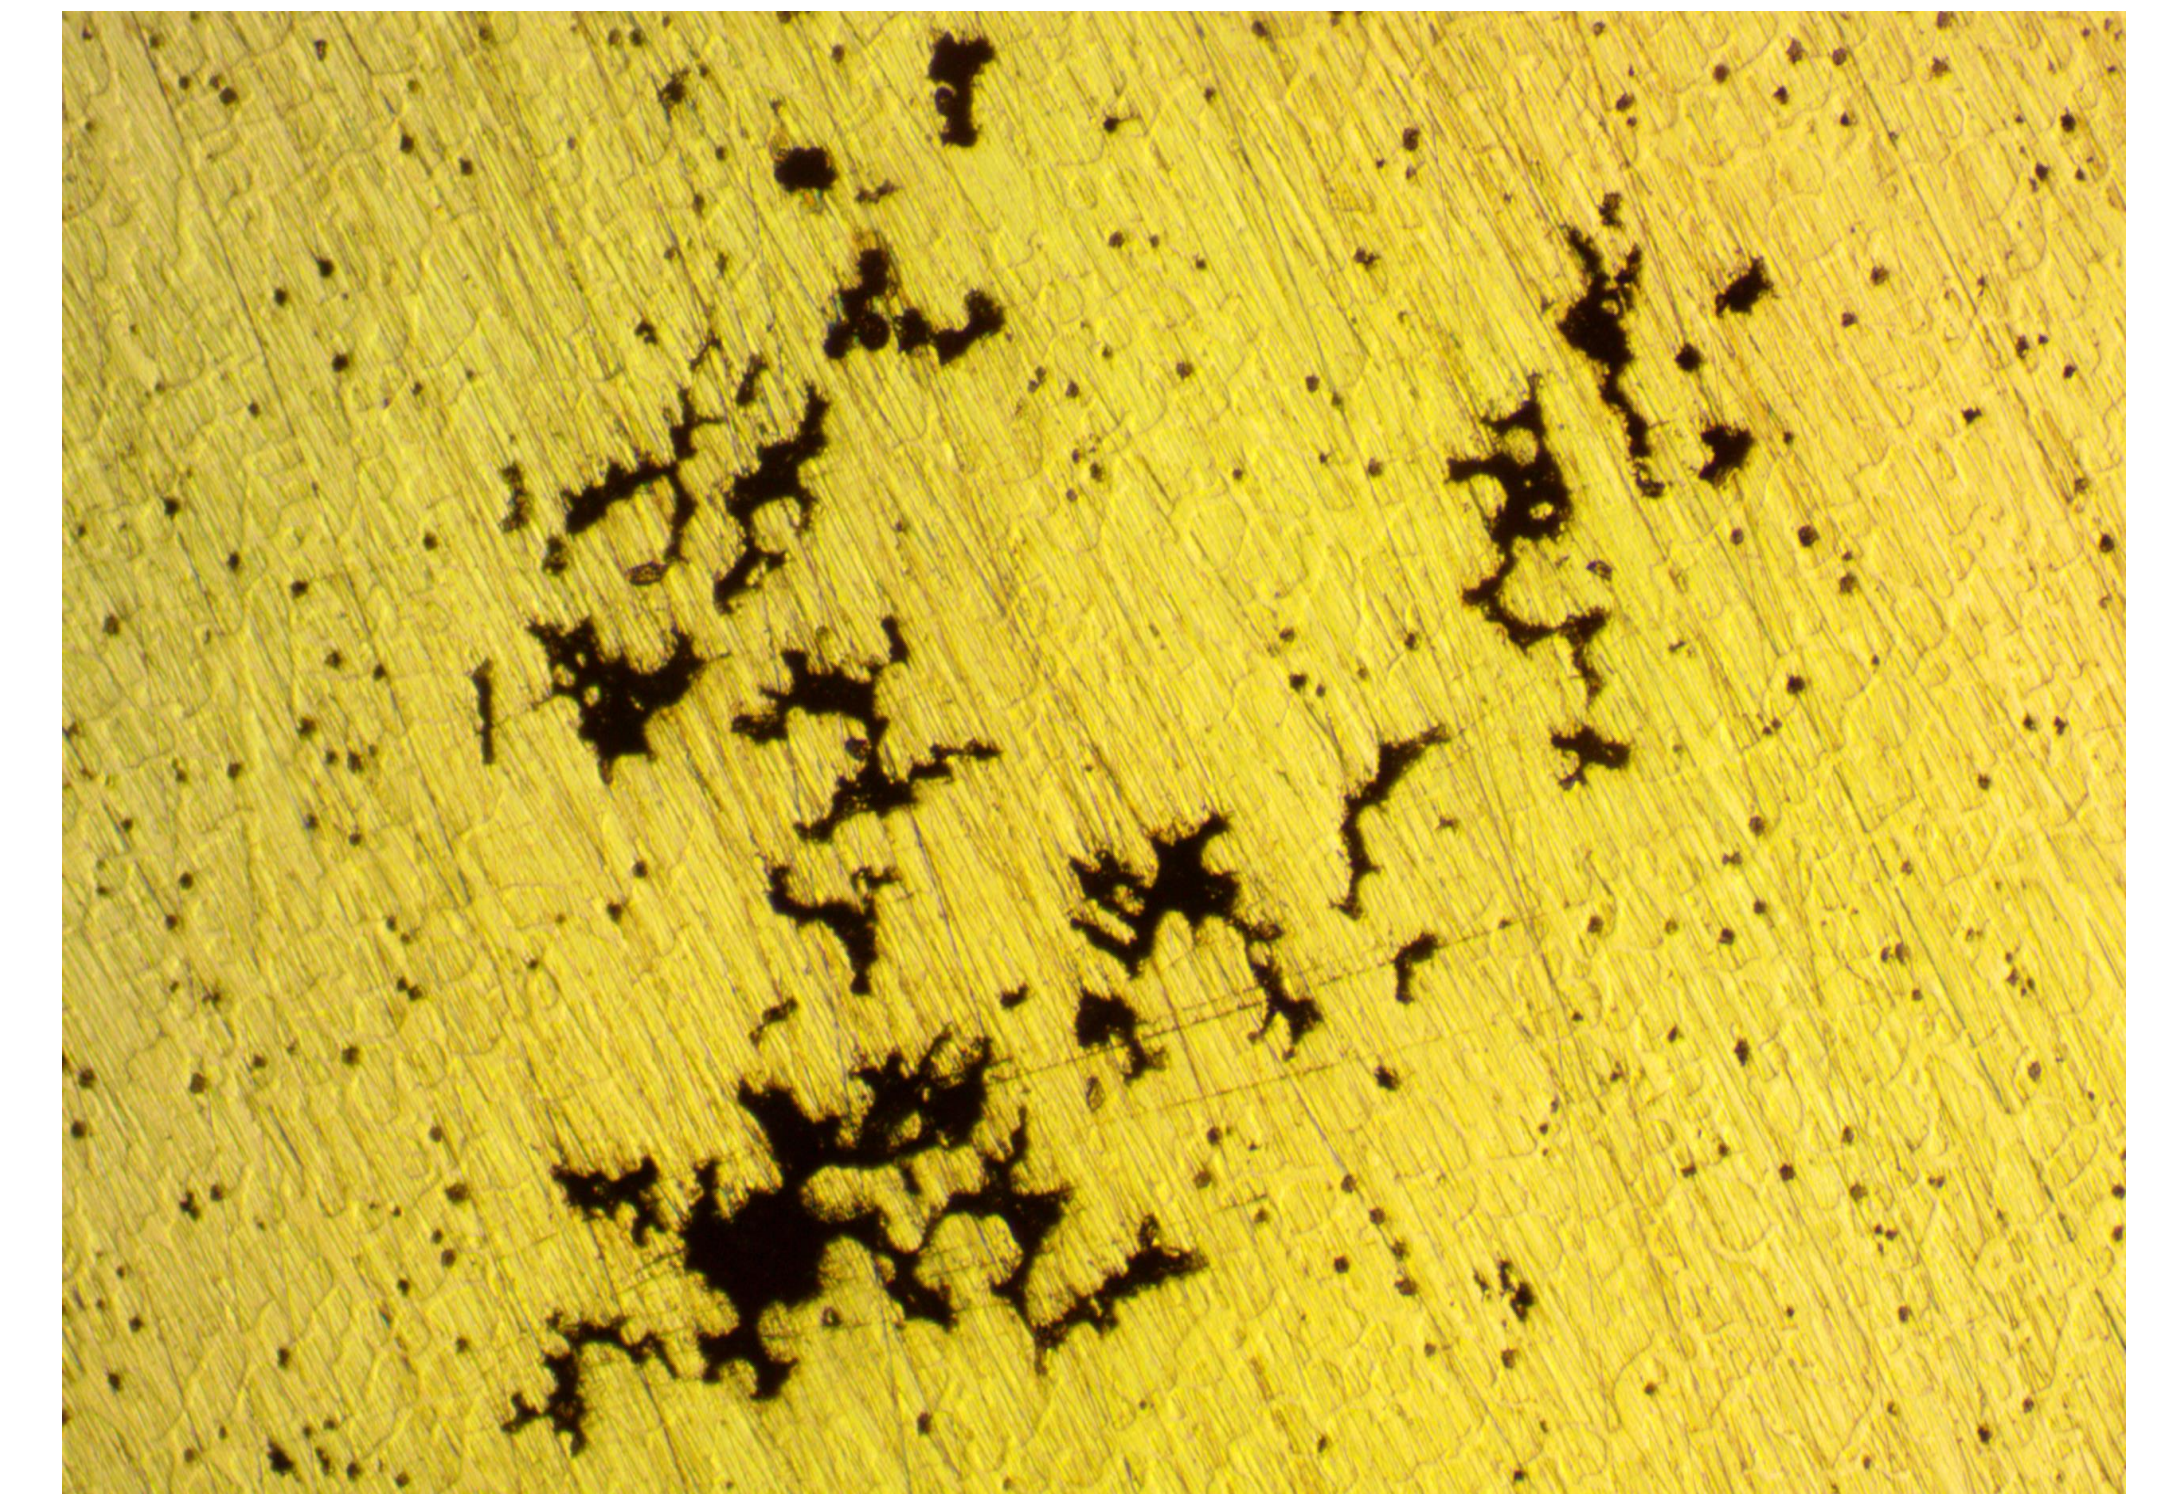
The photomicrograph above shows the microstructure of the ductile iron that we cast. There are graphite nodules present in the image, which proves that we successfully cast ductile iron. Also, micro-shrinkage is depicted in the image above. This is a defect caused by the metal shrinking as it cools and solidifies. There are two factors that we believe may have contributed to the shrinkage defects. The main factor is undersized risers. The risers are significantly undersized, so they were not able to sufficiently feed the test bars as they solidified. The other factor is that we lost a lot of the carbon content due to equipment issues during the operations, so our graphite nodules were very small, which may have contributed to excess shrinkage.

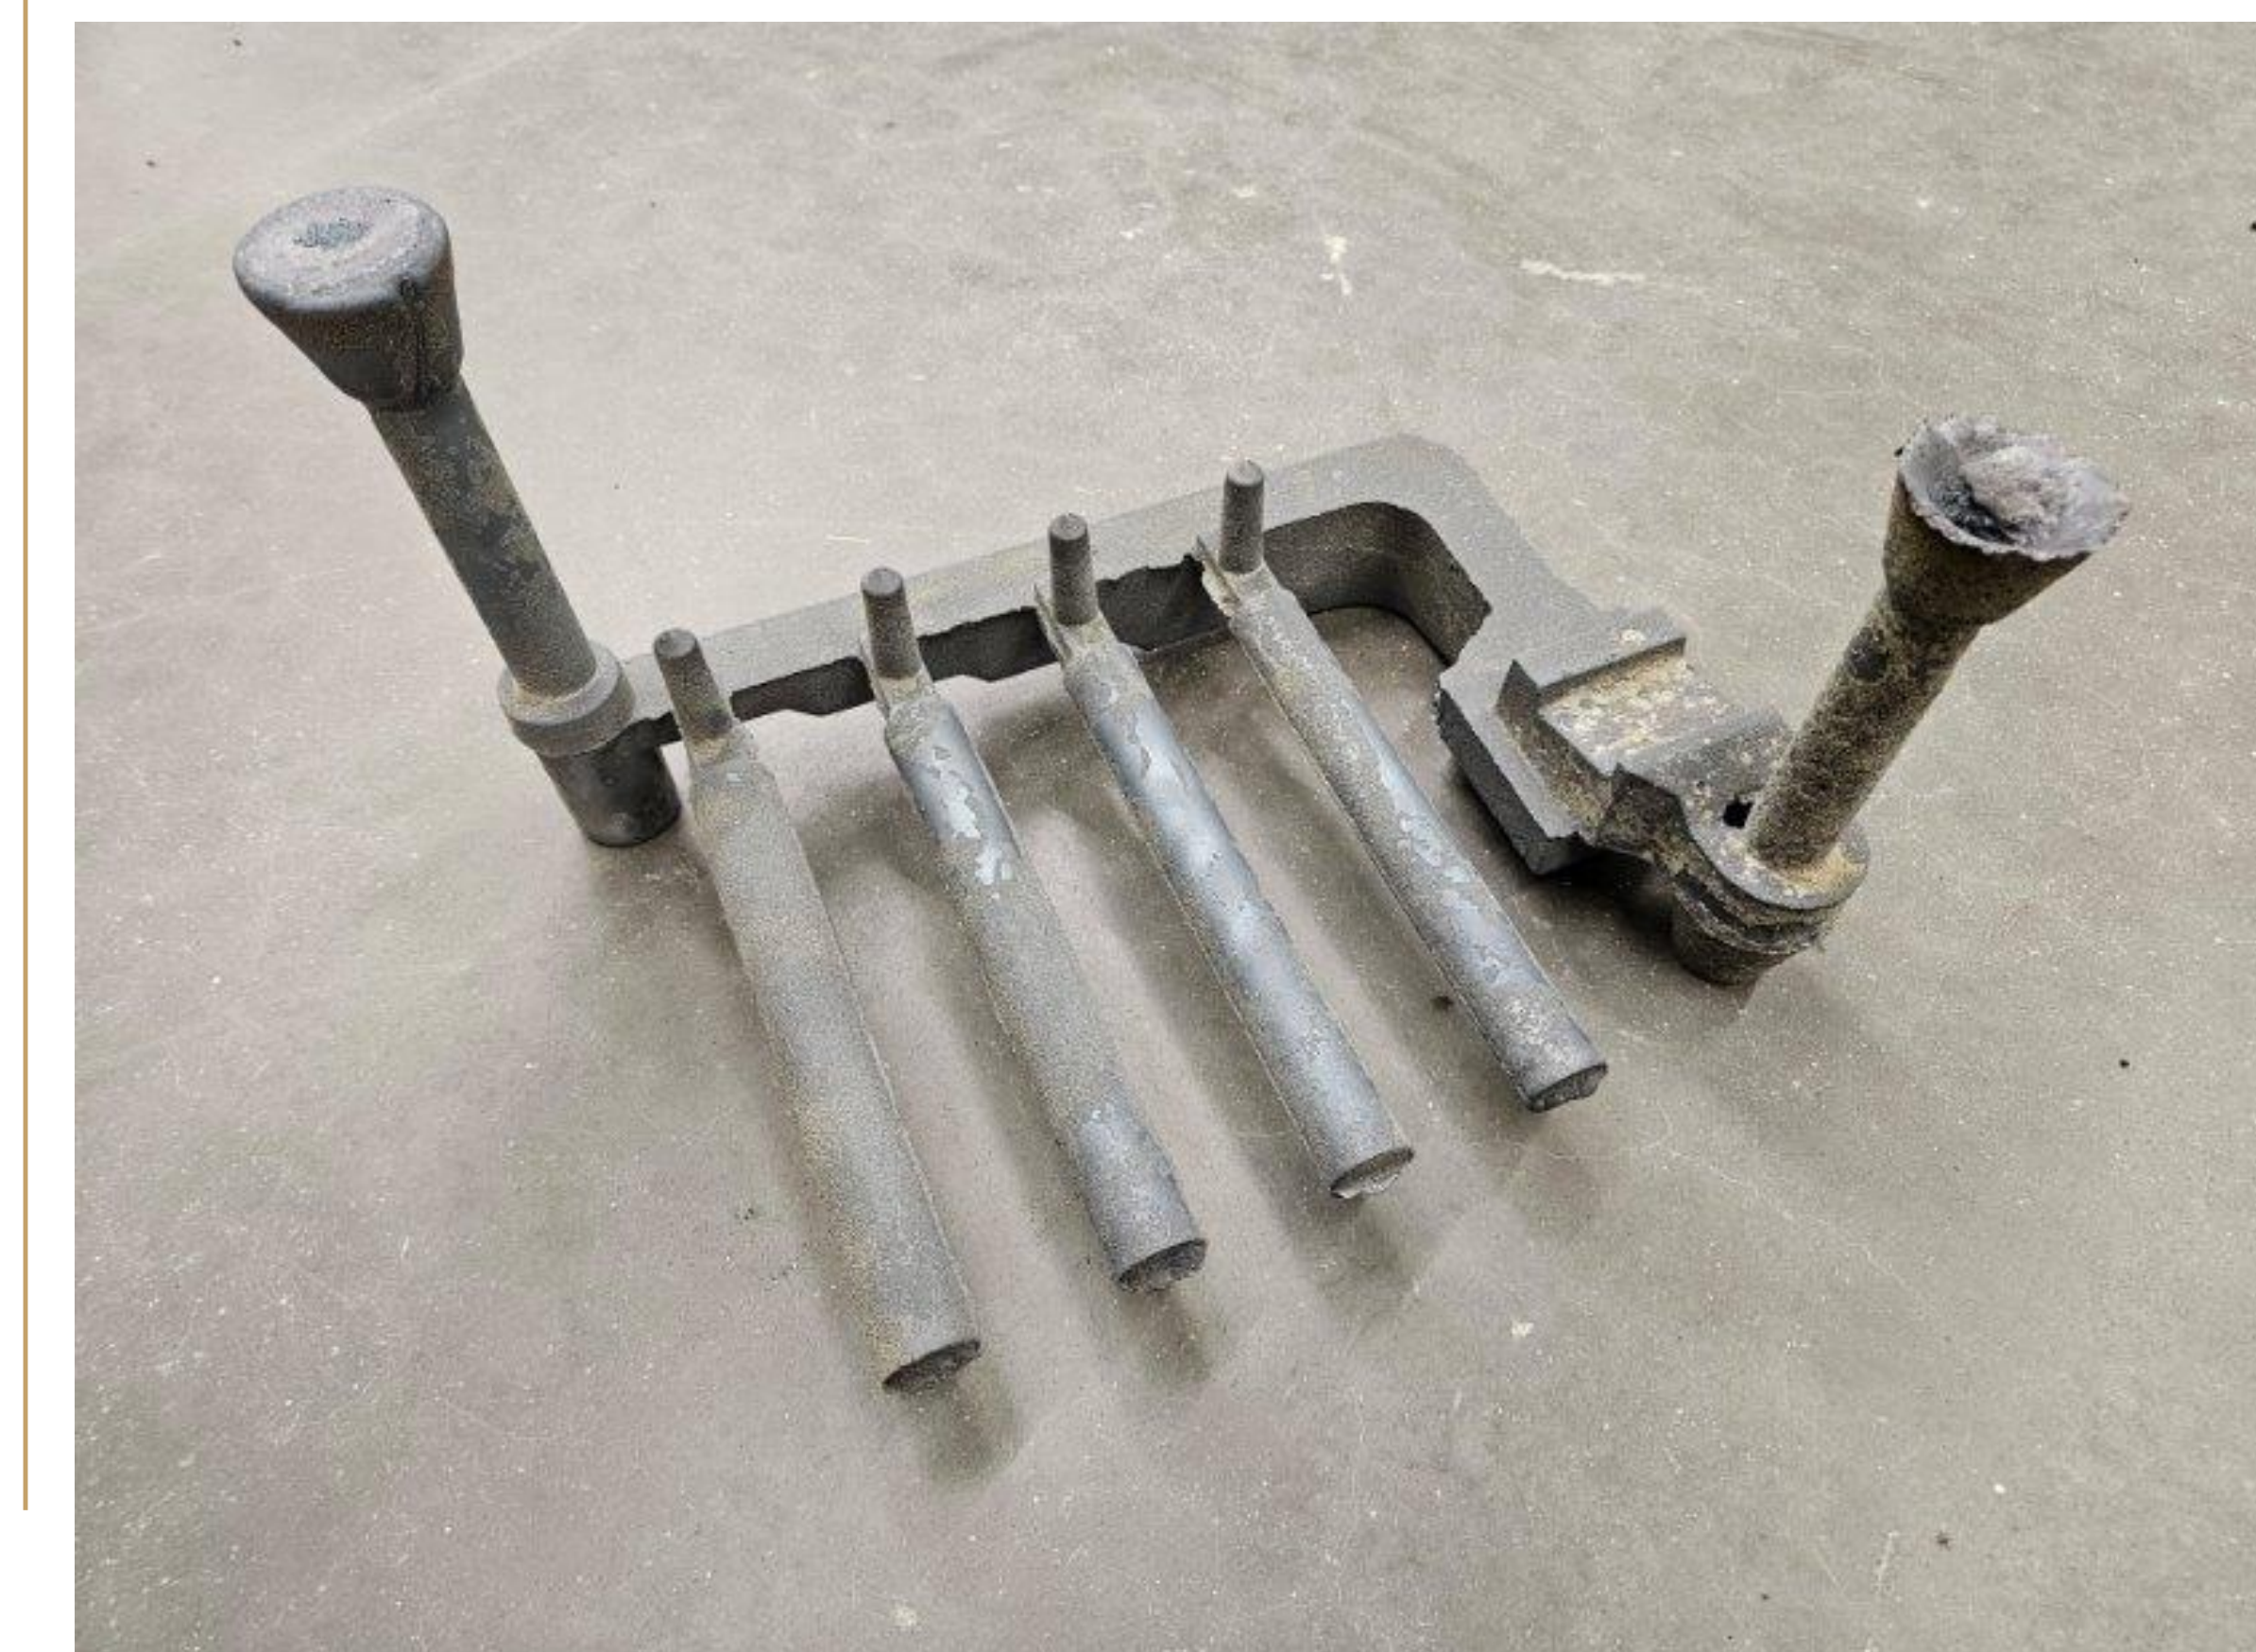
The image shown below is one of our casting. The mold was completely filled and there are no large defects seen in the castings.
